**Report No:** AMC01  
**Date:** 29<sup>th</sup> January 1997  
**Author:** Tobit Curteis Associates  
36 Abbey Road, Cambridge CB5 8HQ.  
Tel/Fax 01223 501958

The late 13<sup>th</sup> century paintings in the north transept at Holy Rood, Ampney Crucis are the last surviving areas of a much larger decorative scheme. The paintings, which depict a series of saints, including a scene from the life of St Edward the Confessor, almost unique in English wall paintings, are unusually fine for a parish church of this size. Partly as a result of the restoration treatment which they received earlier this century, but mainly as a result of the adverse environmental conditions, certain areas of the paintings are now in an extremely unstable condition. This is particularly the case on the north wall where, as a result of the deterioration of the roof, the paintings are now at a stage where serious loss is likely to occur if emergency intervention does not take place. However, prior to any such intervention, measures should be undertaken to control the causes of deterioration. The first area that should be addressed is the condition of the roof and subsequently the environmental conditions withi

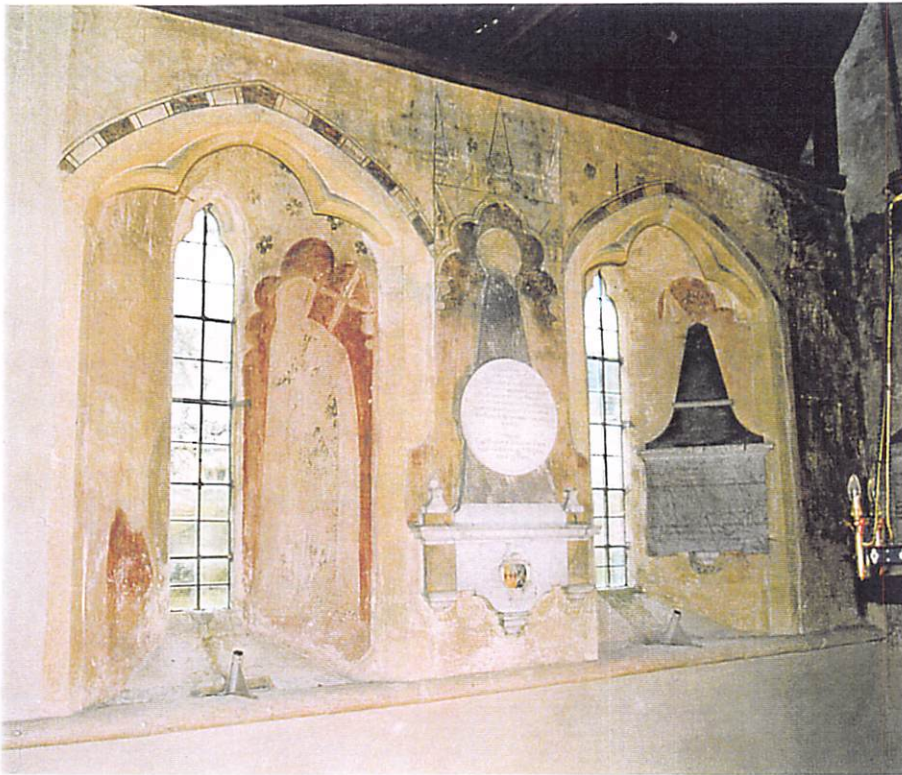
On the west wall, only the paintings above the string course and in the window splays have survived. (Plate 1) The main subjects on the wall are two standing figures of saints, supported in elaborately

**Plate 1.** (Left) General view of the west wall.  
*(Photo: Tobit Curteis Associates 1997)*

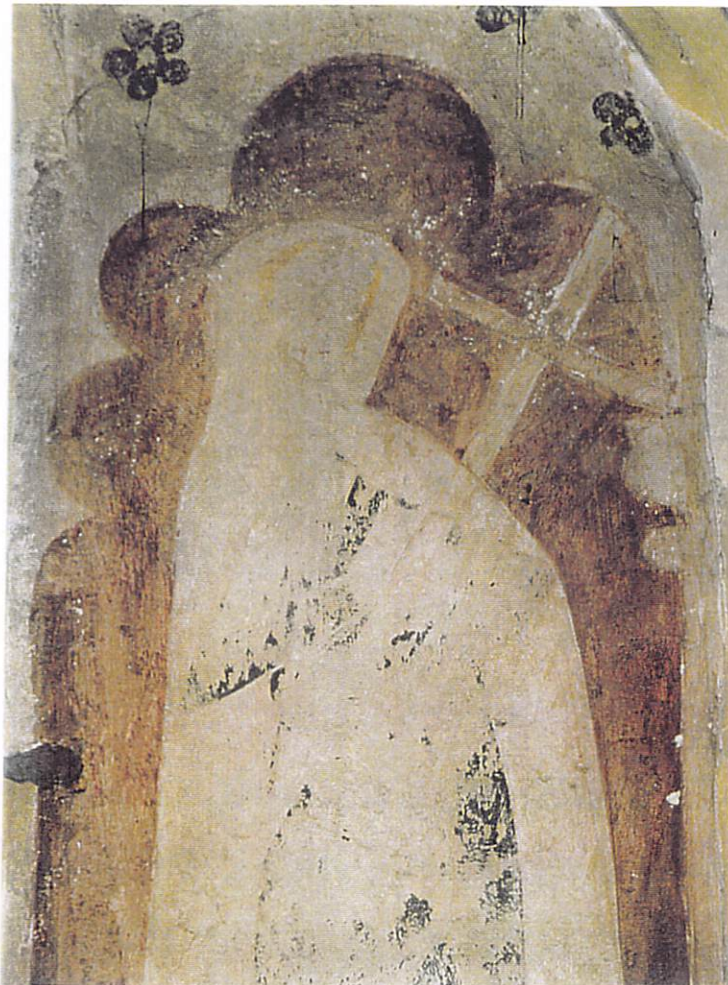
In the south window, a figure of St Helena carrying the cross is painted on the north splay. (Plate 2) The yellow haired figure, who is dressed in a dark robe and white cloak is set in a cusped niche, below a series of cinquefoil florets, which cover the soffit of the arch. A fragment of painting on the south splay is all that remains of the corresponding figure. On the south splay of the north window is a figure of St Paul dressed in a red robe with a dark cloak and holding a sword (pommel down). (Plates 4 & 5) On the north splay is the remains of a bearded figure in a mitre. However, like the painting between the windows, the main part of this scene has been lost behind a monument inserted in 1781. (Plate 6)

**Plate 2.** (Below left) Detail of the north splay of the south window showing the figure of St Helena. *(Photo: Tobit Curteis Associates 1997)*

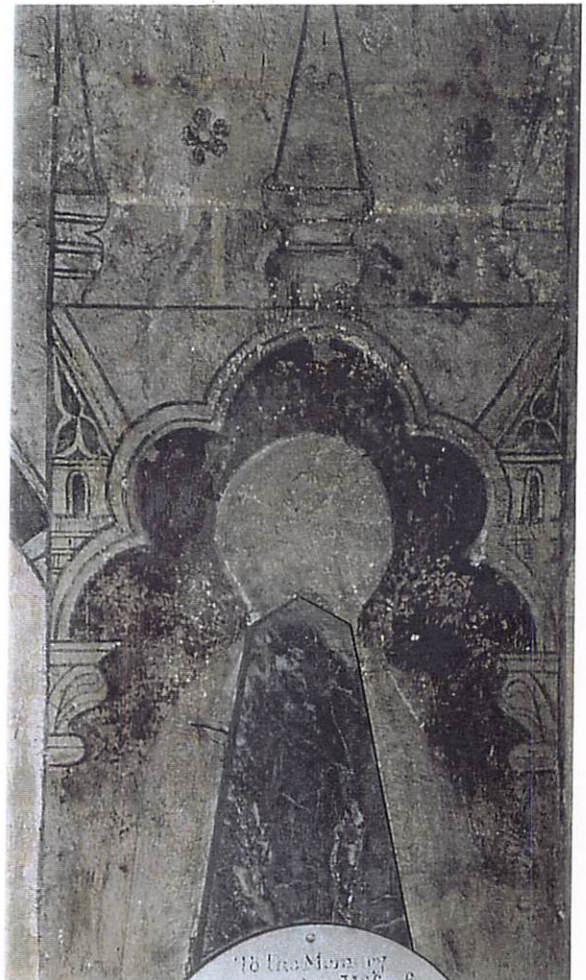
**Plate 3.** (Below right) Detail of the ornate cinquefoil niche between the windows. *(Photo: Tobit Curteis Associates 1997)*

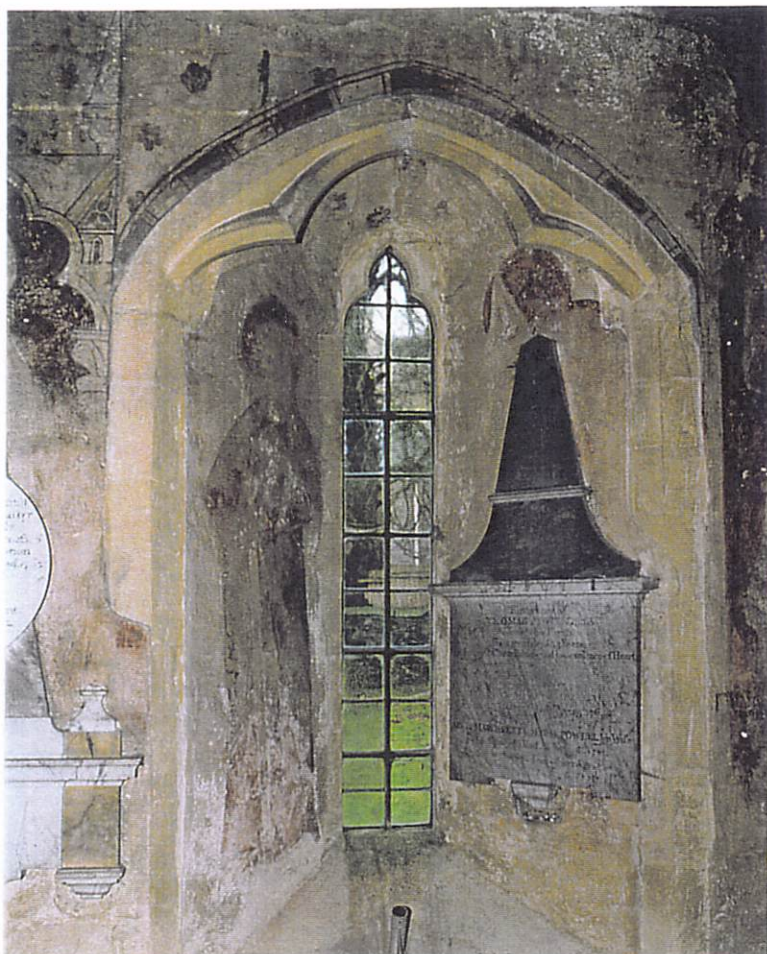
**Plate 4.** (Above left)  
General view of the north  
window on the west wall.  
*(Photo: Tobit Curteis Associates  
1997)*

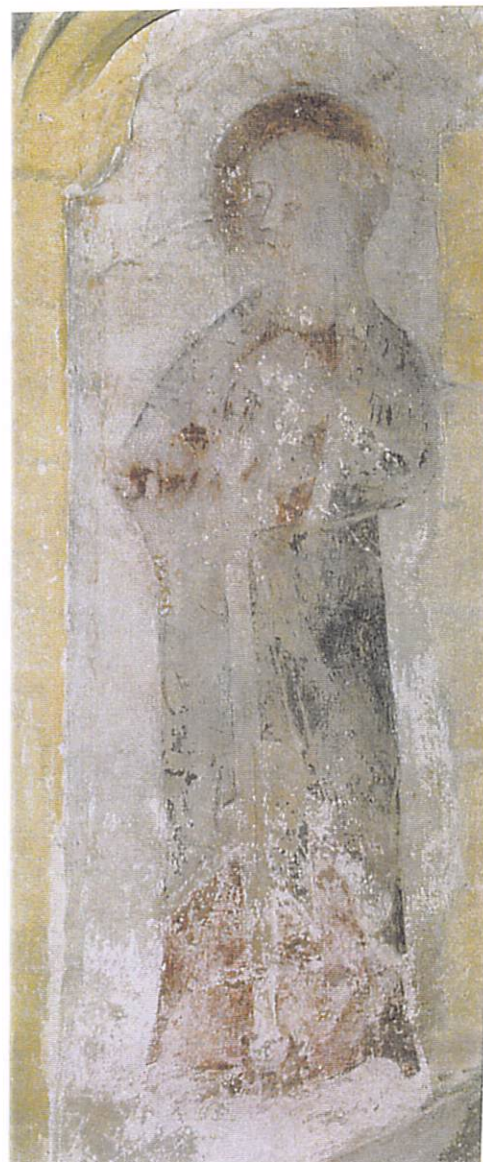
**Plate 5.** (Above right)  
Detail of the figure of St  
Paul on the south splay.  
Note the level of  
deterioration on the lower  
area. *(Photo: Tobit Curteis  
Associates 1997)*

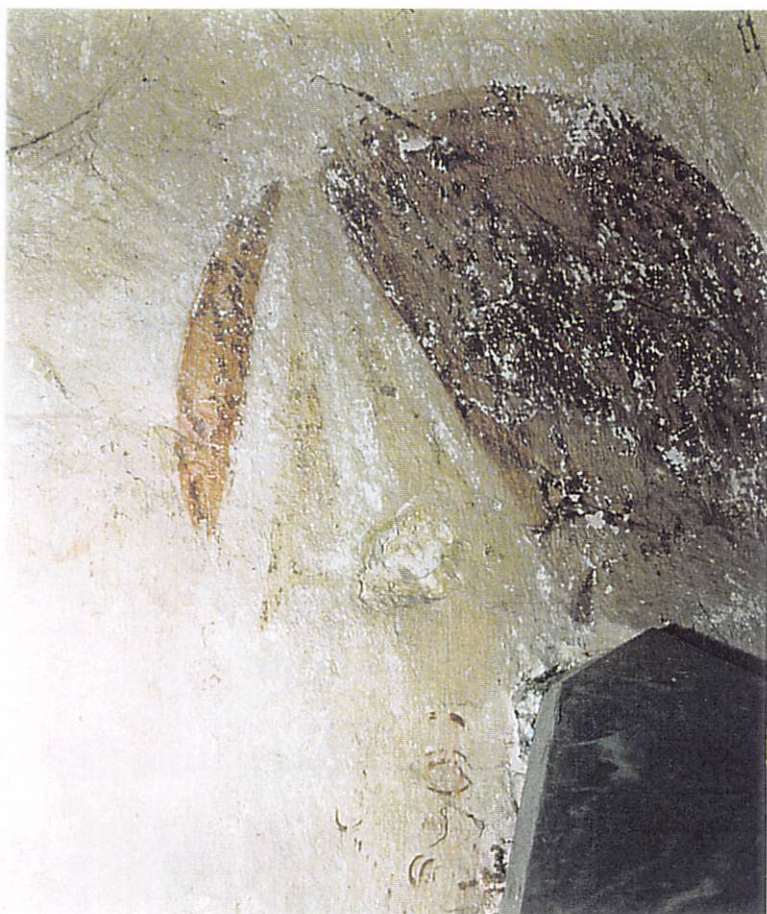
**Plate 6.** (Left) Detail of the  
head of a figure on the  
north splay. Note the  
extensive delamination and  
flaking of the red  
background. *(Photo: Tobit  
Curteis Associates 1997)*

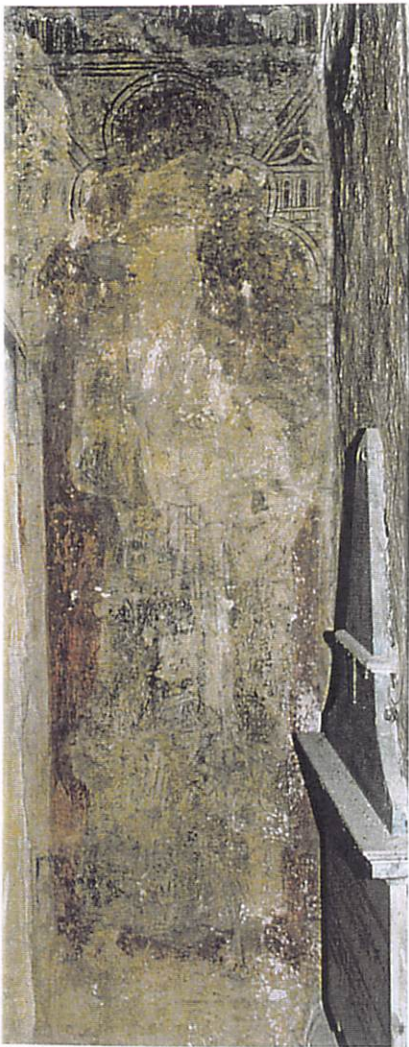
The most serious damage had occurred on the north end of the wall, where the distribution of the delamination and flaking of both the paint layer and the plaster substrate, were characteristic of long term water infiltration. Large areas of the upper part of St James were no longer visible and it was clear that extensive loss has occurred in this area since it was restored. The deterioration appears to be active and some large sections are in an extremely unstable condition and are vulnerable to further loss.

**Plate 7.** (Above left) Detail of the figure of St James on the extreme north side of the west wall. (Photo: Tobit Curteis Associates 1997)

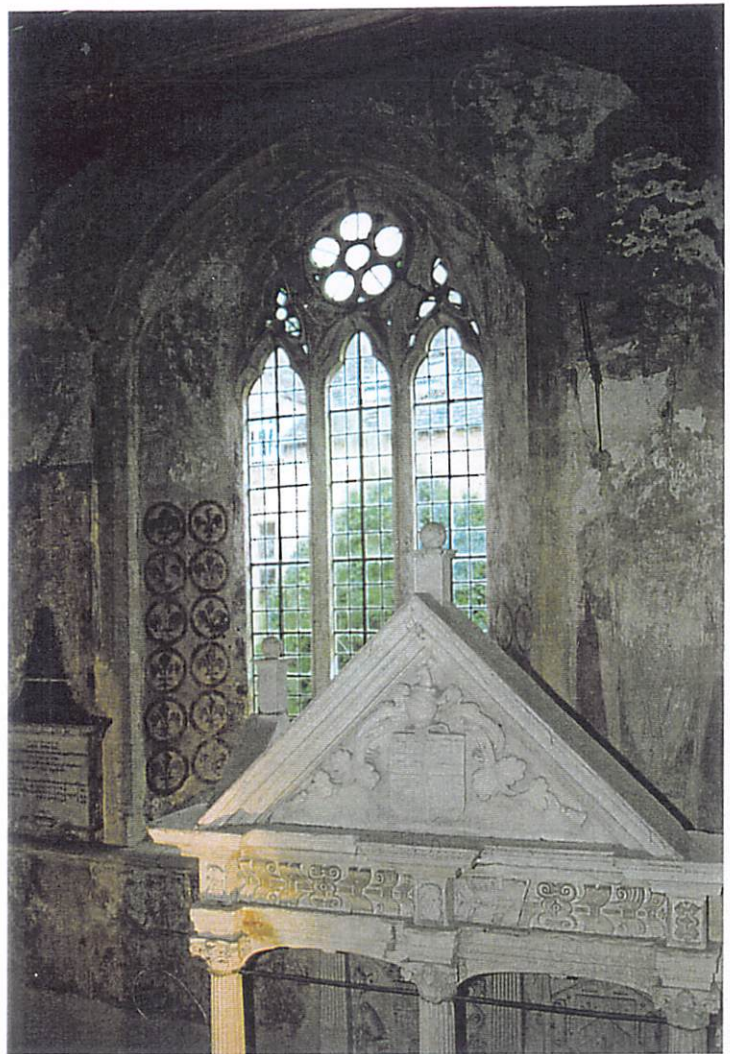
The scenes from the life of Christ are continued on the lower part of the north wall, below the dado on the west side.<sup>6</sup> (Plate 8) Although the paintings survive, they are extremely badly damaged and can only be made out in certain areas. The upper part of the painting consists of a series of coats of arms, including part of a lion rampant, a bend and vair (black and white fur), believed to be those of Fitzhamon of Tewkesbury.<sup>7</sup> Below these are finely painted fragments of the Life of Christ. (Plate 9) However the damage is such that no clear subject is apparent.

**Plate 8.** (Above right) General view of the north wall. (Photo: Tobit Curteis Associates 1997)

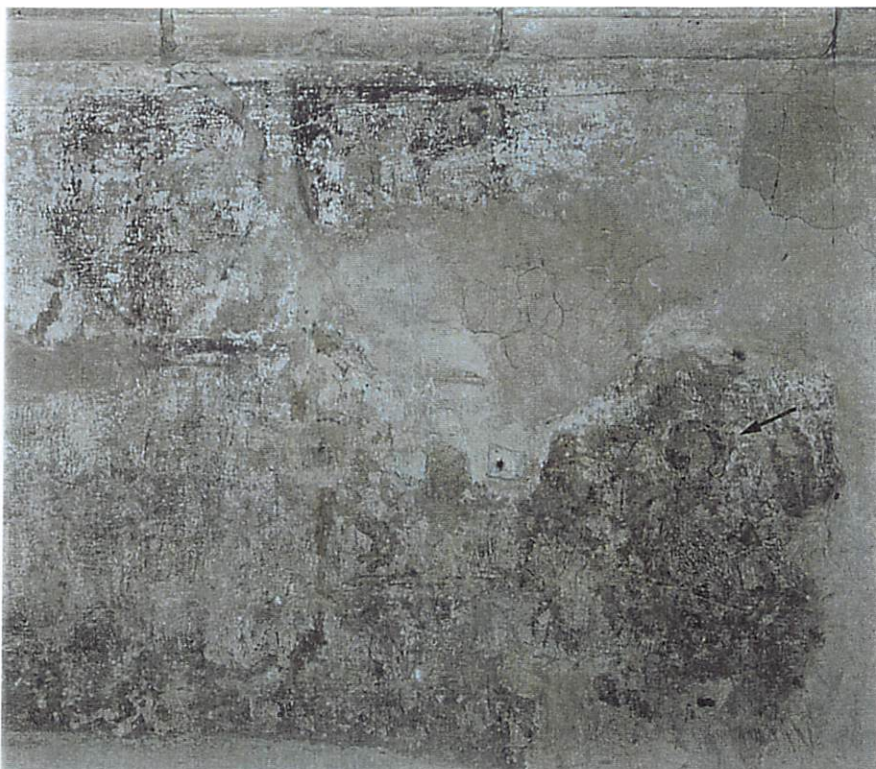
**Plate 9.** (Left) Detail of the lower west side below the string course. The figure (a detail of which is seen in plate 33) is indicated by the arrow. (Photo: Tobit Curteis Associates 1997)

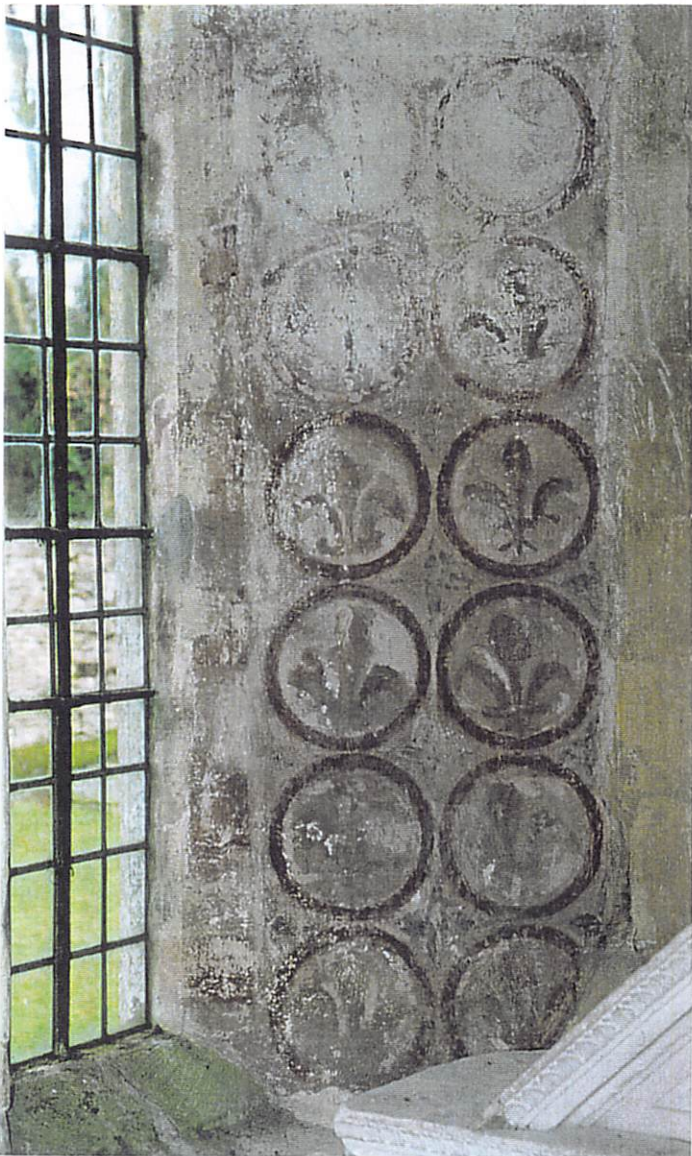
**Plate 10.** (Above left) Detail of the east splay on the north window showing the fleur de lys decoration. (Photo: Tobit Curteis Associates 1997)

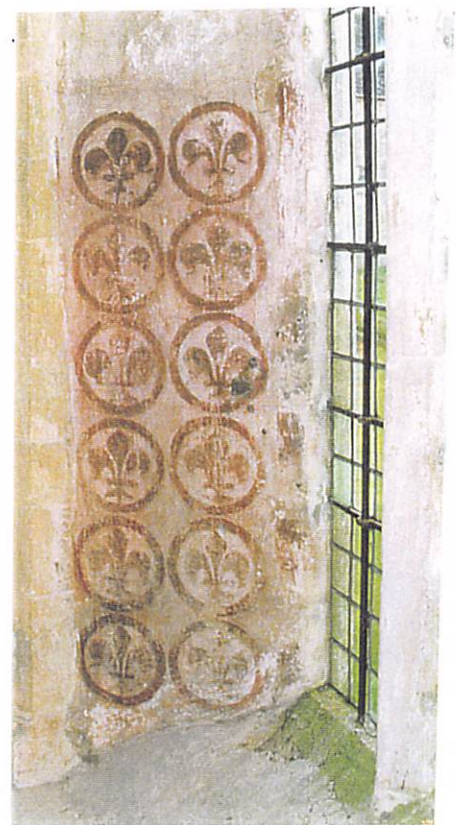
The levels of delamination and flaking which result from soluble salt activity, as well as the microbiological growth observed at the base of the windows, also appear to result from high levels of humidity or fluctuations in humidity. This problem is probably exacerbated by the lack of air movement resulting from an absence of ventilation, which is likely to encourage the formation of condensation.

**Plate 12.** (Above) Detail of the fleur de lys decoration on the west splay of the north window. Note the microbiological growth at the base of the window. (Photo: Tobit Curteis Associates 1997)

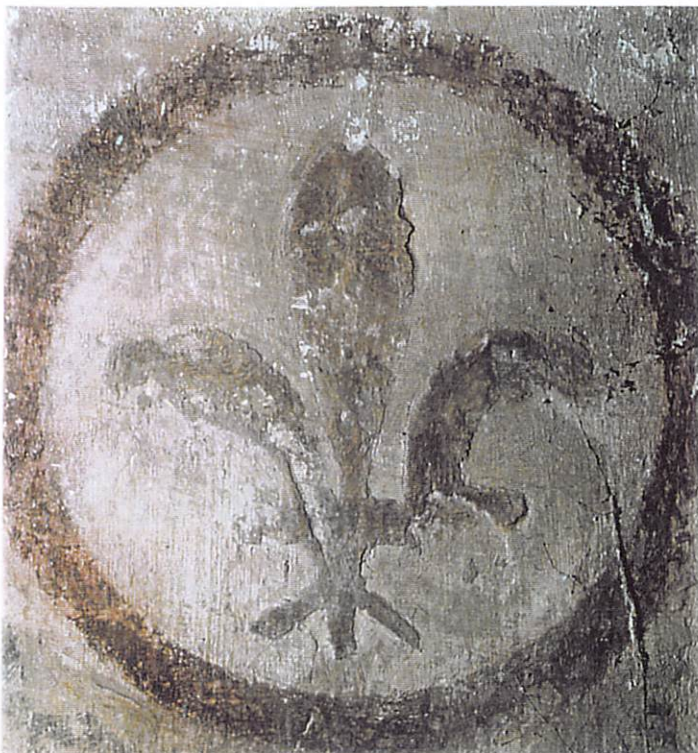
**Plate 11.** (Left) Raking light detail of the previous plate showing one of the fleur de lys. Note the incision lines and the delamination of the paint layer. (Photo: Tobit Curteis Associates 1997)

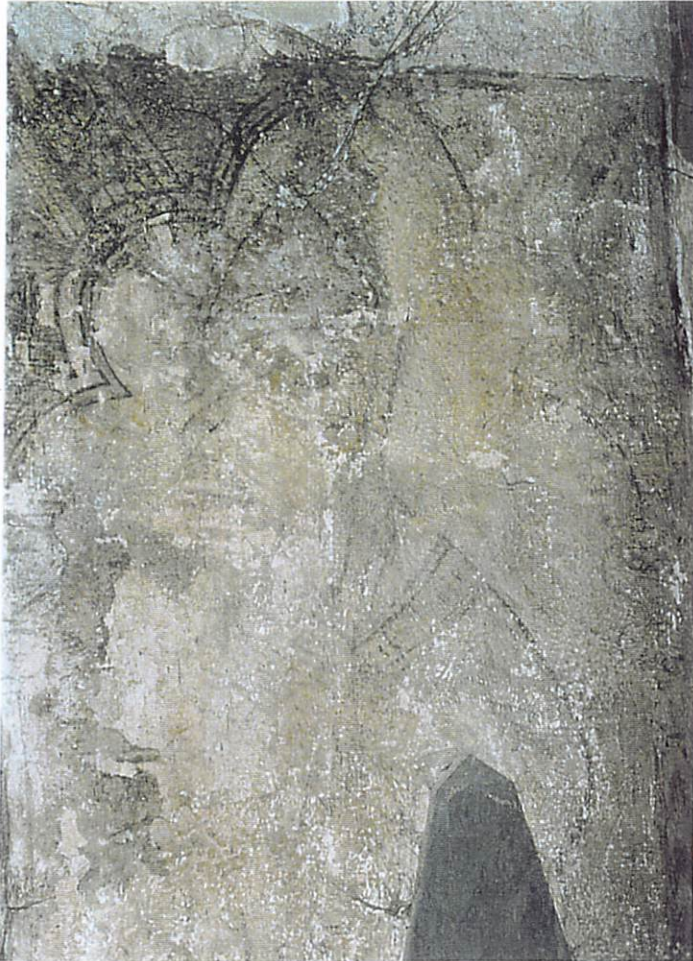
The north wall is in by far the most serious and unstable condition. The bishop (or archbishop) on the west side is in a condition similar to that of St James. Delamination and flaking of the paint layer and the substrate is widespread and the level of loss is high. The condition of the corresponding figure on the east side is curious as, although the upper section has been almost completely destroyed, the lower part including much of the vestments, is in reasonably good condition. Like the paintings on the west wall, the two figures have been treated with a wax coating.

**Plate 13.** (Above left) Detail of the west side of the north wall showing the upper part of the figure in the cinquefoil niche. (Photo: Tobit Curteis Associates 1997)

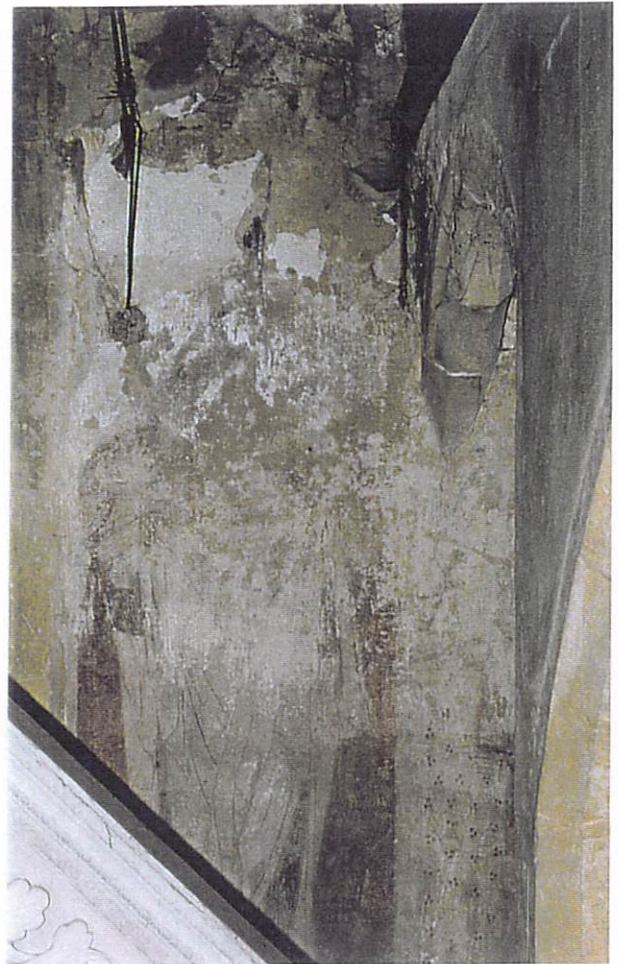
**Plate 14.** (Above right) Detail of the east side of the north wall showing the second figure, the upper half of which is almost totally destroyed. (Photo: Tobit Curteis Associates 1997)

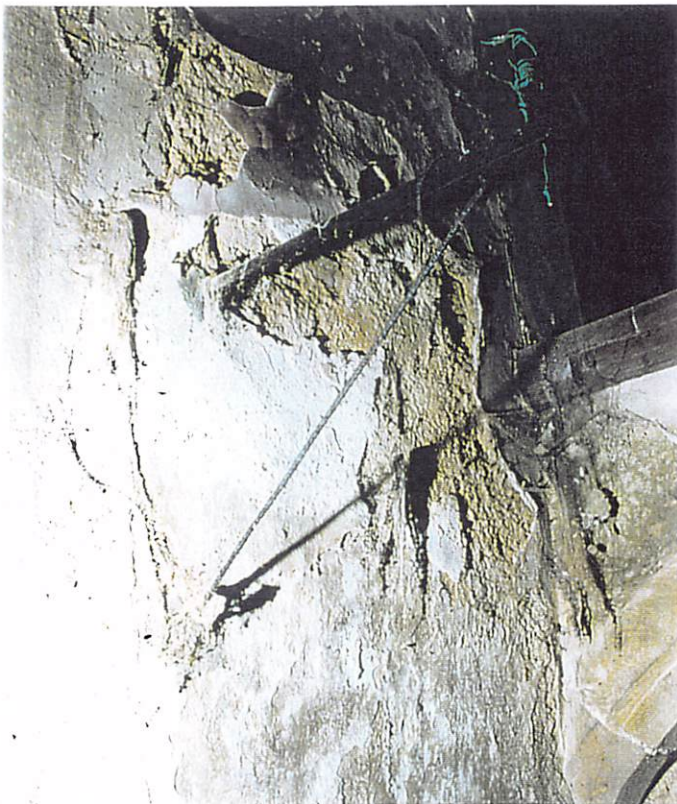
The seriousness of the condition of the wall above the window cannot be overemphasised. On the east side, the plaster has delaminated from the stone substrate by up to 20cm in places. (*Plate 15*) There is widespread loss and large pieces of recently detached plaster were found on top of the tomb canopy. (*Plate 16*) Most of the surface in this area is still coated with limewash and little painting, presumably masonry pattern, is currently visible. There appear to be a number of large old repairs in this area, which are also delaminating.

**Plate 15.** (Left) Raking light detail of the upper part of the previous plate showing the extremely serious delamination of the plaster layer. (Photo: Tobit Curteis Associates 1997)

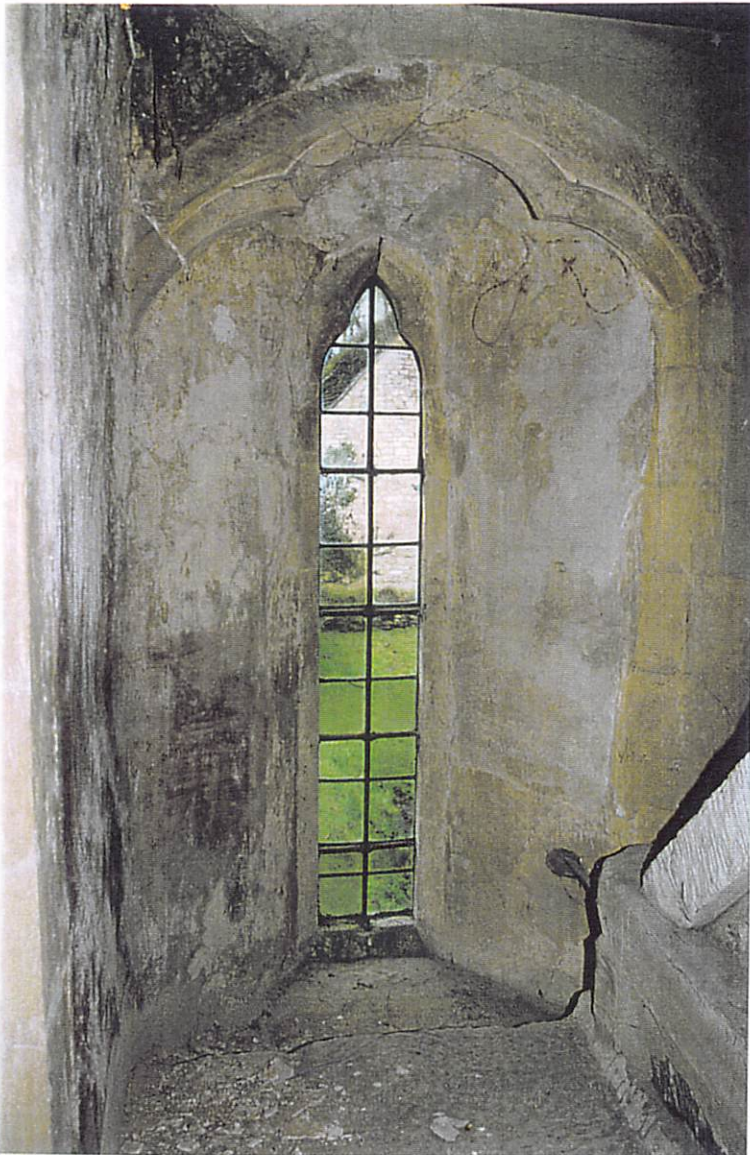
**Plate 16.** (Above left) General view of the north window on the east wall, showing the damaged figure on the north splay. Note the plaster at the base which has recently fallen from the area shown in plate 15. (Photo: Tobit Curteis Associates 1997)

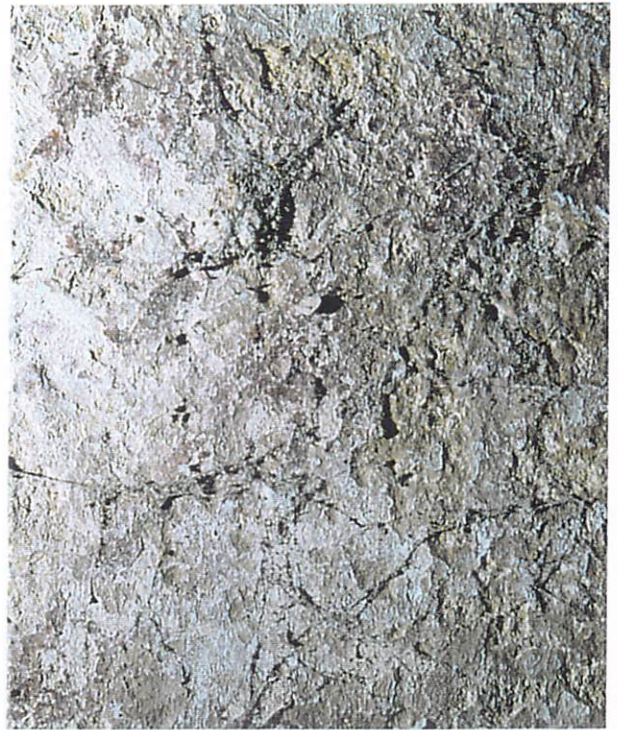
Much of the detail of the figure on the north splay of the north window has been lost as a result of the flaking of the paint layer. (*Plate 17*) The north side of the soffit has lost both the paint layer and the upper part of the plaster layer. On the south splay, most of the plaster has been replaced with a large repair. The foliate decoration in the soffit, although damaged, is not as unstable as elsewhere.

**Plate 17.** (Above right) Raking light detail of the damaged surface of the north splay of the window. (Photo: Tobit Curteis Associates 1997)

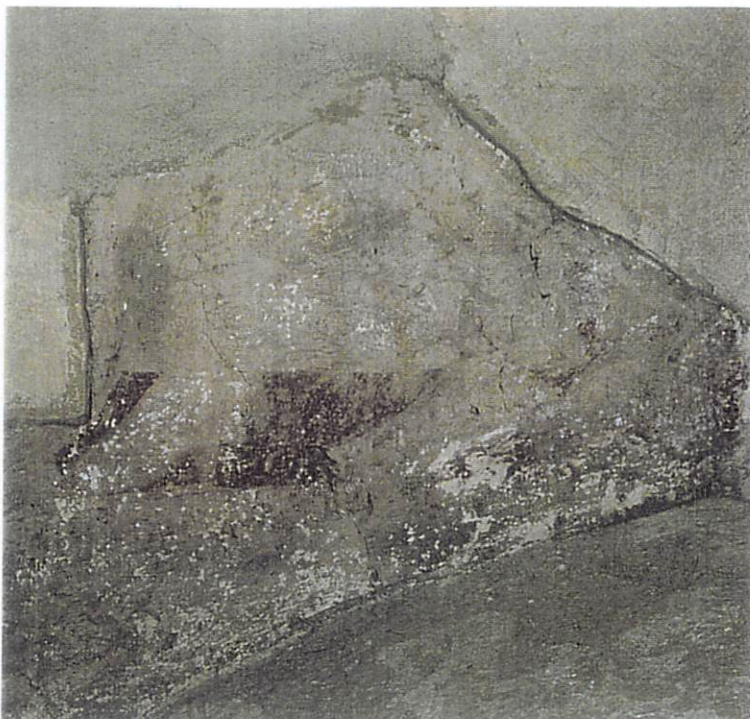
**Plate 18.** (Left) Detail of the lower part of the north splay of the south window on the east wall, showing the feet of a standing figure. (Photo: Tobit Curteis Associates 1997)

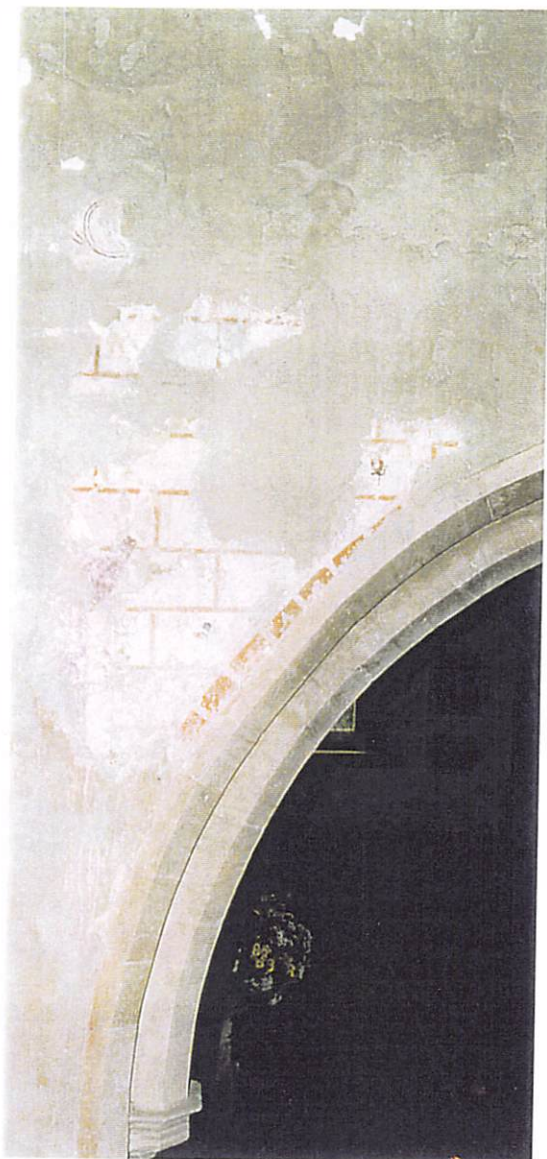
**Plate 19.** (Above) General view of the east side of the south wall.  
*(Photo: Tobit Curteis Associates 1997)*

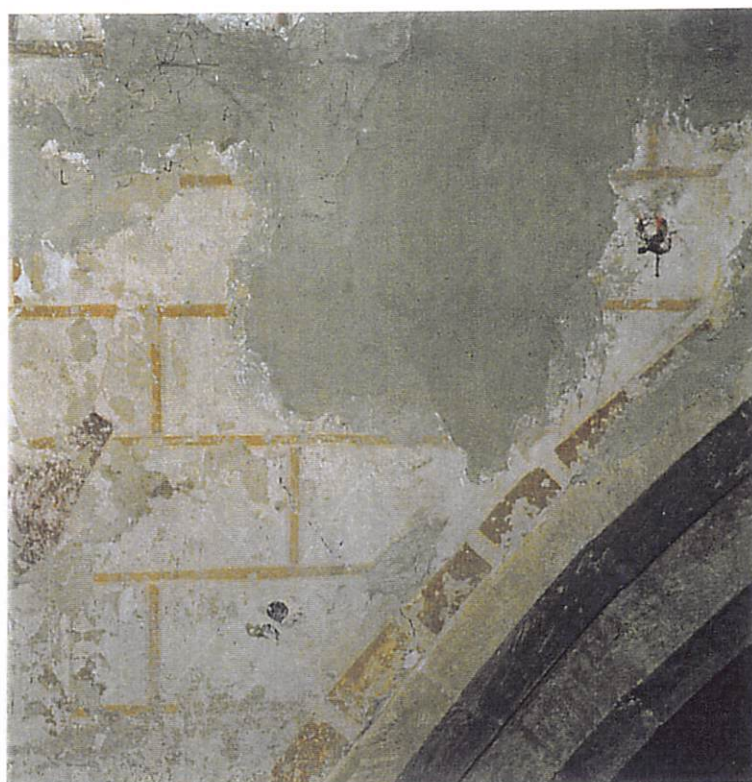
**Plate 20.** (Above right) Detail of the previous plate showing the figure of St Edward holding the ring.  
*(Photo: Tobit Curteis Associates 1997)*

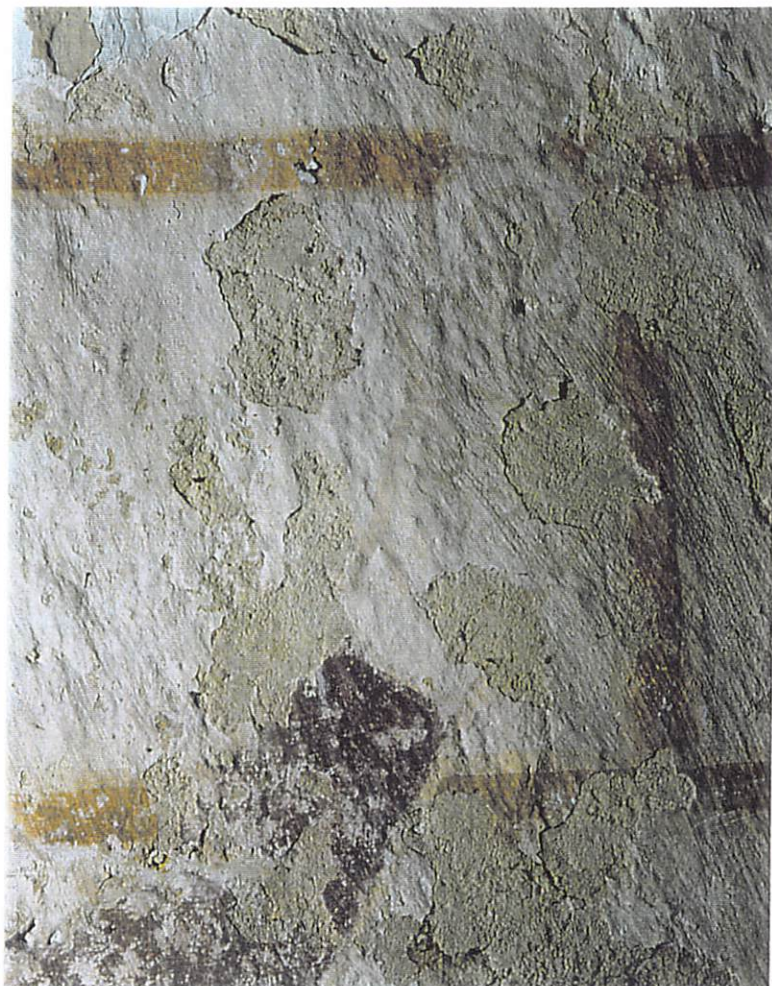
**Plate 21.** (Right) Raking light detail of the area around St Edward's hand showing the level of delamination. Note the mud render below the paint layer.  
*(Photo: Tobit Curteis Associates 1997)*
