**Report No:** AMC01  
**Date:** 29<sup>th</sup> January 1997  
**Author:** Tobit Curteis Associates  
36 Abbey Road, Cambridge CB5 8HQ.  
Tel/Fax 01223 501958

The late 13<sup>th</sup> century paintings in the north transept at Holy Rood, Ampney Crucis are the last surviving areas of a much larger decorative scheme. The paintings, which depict a series of saints, including a scene from the life of St Edward the Confessor, almost unique in English wall paintings, are unusually fine for a parish church of this size. Partly as a result of the restoration treatment which they received earlier this century, but mainly as a result of the adverse environmental conditions, certain areas of the paintings are now in an extremely unstable condition. This is particularly the case on the north wall where, as a result of the deterioration of the roof, the paintings are now at a stage where serious loss is likely to occur if emergency intervention does not take place. However, prior to any such intervention, measures should be undertaken to control the causes of deterioration. The first area that should be addressed is the condition of the roof and subsequently the environmental conditions withi

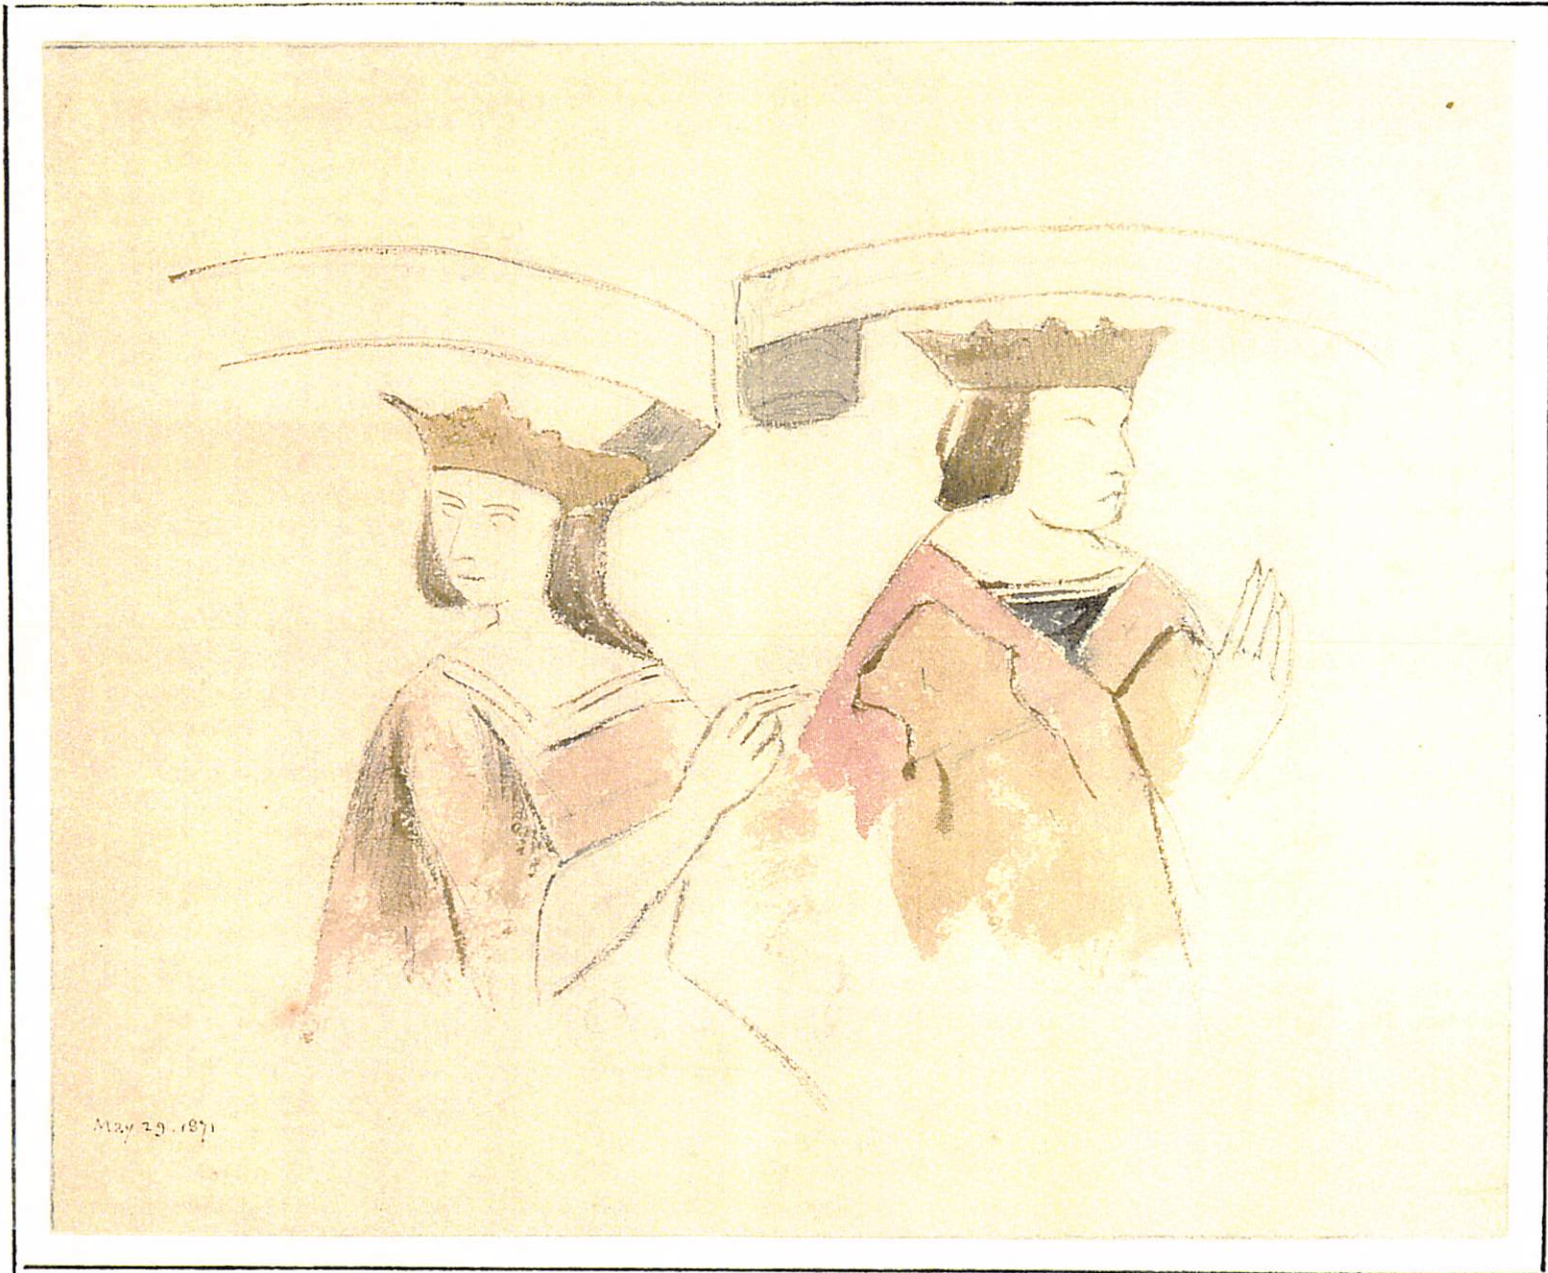
The style and technique of the painting is similar to that elsewhere in the transept and it is clearly part of the same scheme. However, Like the base of the north wall, the substrate consists of a soft mud render. The paint layer itself has little cohesion and in some areas it is powdering. Delamination and flaking have occurred in some areas, but this does not appear to be as extensive as on other walls. (*Plate 21*)

**Plate 21.** (Right) Raking light detail of the area around St Edward's hand showing the level of delamination. Note the mud render below the paint layer.  
*(Photo: Tobit Curteis Associates 1997)*
